Manhole Inspection Summary

Manhole # S25AA1006MH

Location Address: **1300 36TH ST**

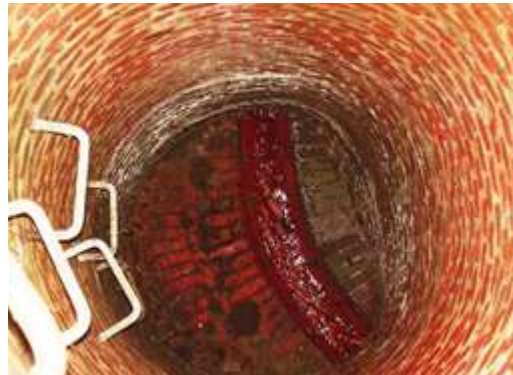
Top View

Barrel infiltration. Corroded steps.
Evidence of surcharge - Bench debris.

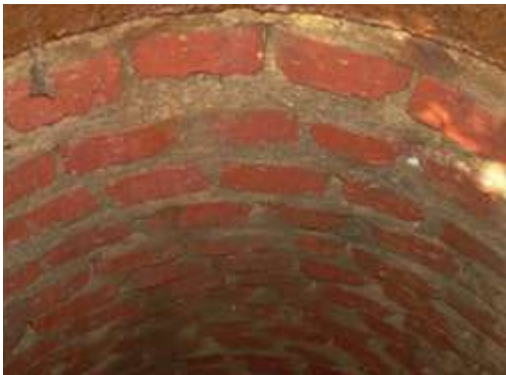
Defect

Frame leaks. Adjustment and Corbel
infiltration.

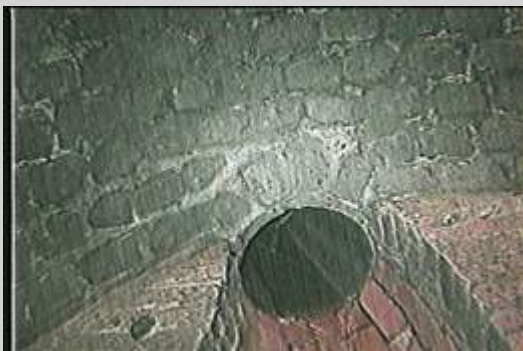
10 in. Circular Gravity Sewer Pipe In @ 5 O'Clock

Barrel deterioration and infiltration. Channel deterioration.
